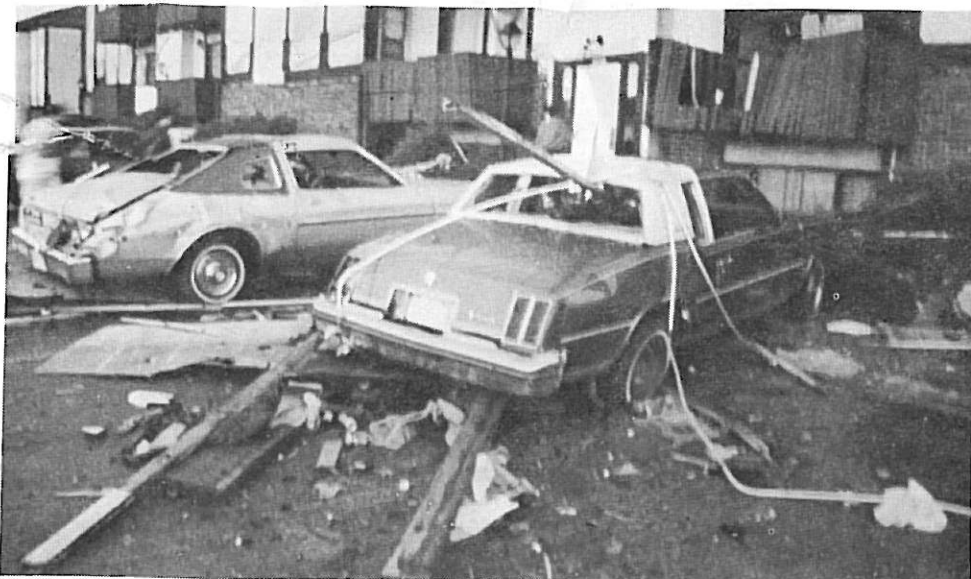
Damaged cars outside of a Topeka apartment building. The car in the foreground had a 2x4 inch board driven through its rear window, and was pushed over the curb and nearly into the window of a lower-level apartment. ---Photo by Bill Barlow, NWSFO at Topeka, Kansas.

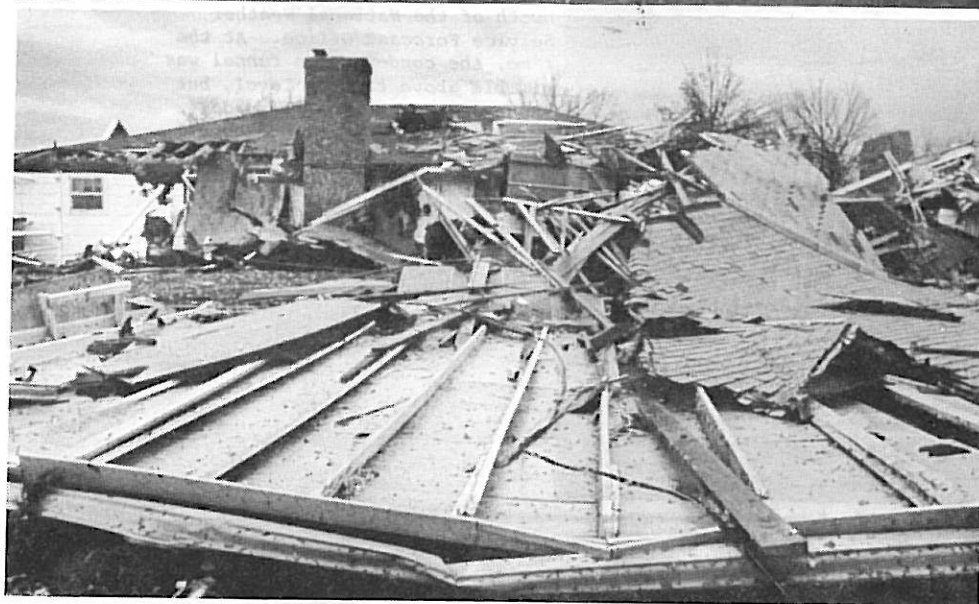
An example of some of the worst damage caused by the Topeka tornado, this flipped over and crumpled roof was torn off of one home and thrown into the back yard of another. Damage to the home in the background, including the hole in its roof, was mainly caused by the flying debris. ---Photo by Bern Ketchum, The Topeka Capital-Journal; and supplied by the NWSFO at Topeka, Kansas.

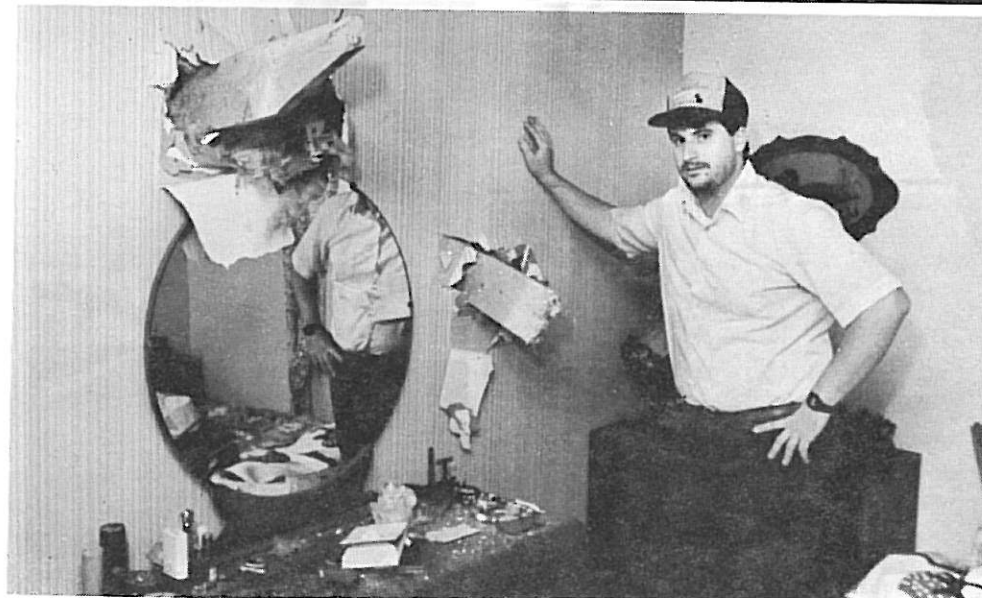
A Topeka homeowner examines the damage done by 2x6 inch boards that were thrust into the south wall of his home by the tornado. The boards seen protruding from the wall are the former airborne missiles and not part of the wall. ---Photo by Thad Allton, The Topeka Capital-Journal; and supplied by the NWSFO at Topeka, Kansas.
